Volunteer Inventory of the Paw Paw River Watershed

**Final Report
8/07/08**

Paw Paw River Watershed Planning Project

Tracking Code: 2005-0115
Grantee: Southwest Michigan Planning Commission
Funding Source: EPA CWA Section 319

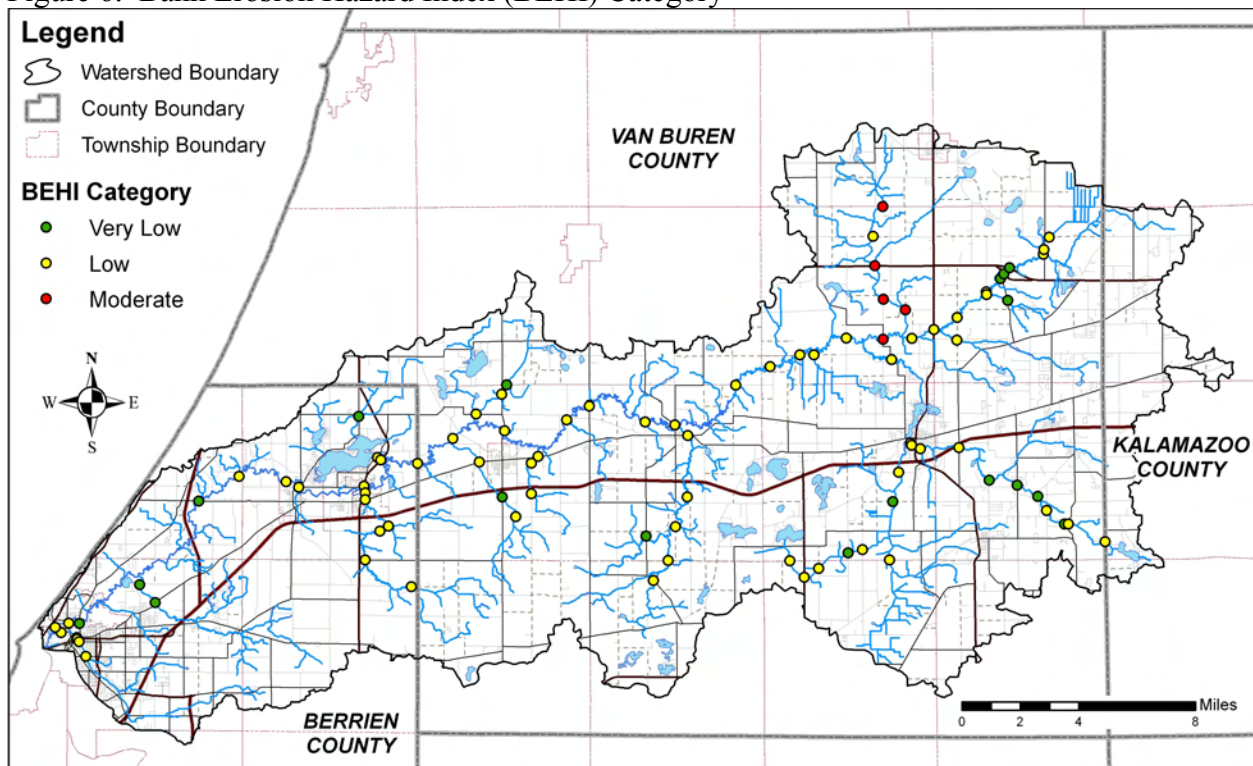
Figure 6. Bank Erosion Hazard Index (BEHI) Category

Bank erosion potential was assessed using a modified version of Rosgen's Bank Erosion Hazard Index (BEHI – see Appendix B). At each inventory site BEHI surveys were completed for the upstream left and right banks, as well as the downstream left and right banks. The scores from all 4 banks were averaged to estimate an overall “site BEHI score” and accompanying category. Overall BEHI scores were low in the PPRW. Several stream banks along Brandywine Creek in northeast Van Buren County received BEHI scores high enough to have 4 sites in the Moderate category. Although there were individual stream banks throughout the PPRW that received high scores, there were no sites with average scores high enough to fall into the High, Very High, or Extreme categories. Figure 6 illustrates the overall site BEHI category for the final volunteer inventory sites.
